Fish Passage & Diversion Screening Inventory Database Report Cover Sheet

Site Description Report

Level A Culvert Assessment Report

Site ID: **994327**
 Latitude: **47.70835** Stream: **Sam Snyder Cr** WRIA: **15.0293**
 Longitude: **-122.60318999** Tributary To: **Liberty Bay** Fish Use Potential: **Yes**

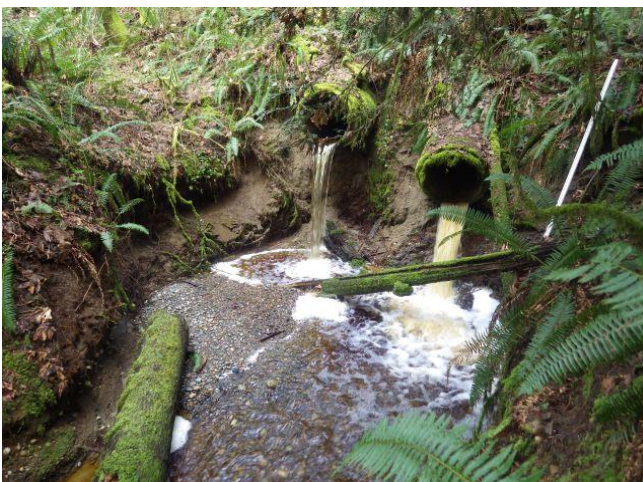
1.2 = This one is LB pipe- most DS section falling/breaking away, water flowing out of bottom. 2.2 = This one is RB pipe. Steep, deep, brushy fill. Most of flow goes through pipe 2.2 due to debris at inlet.
